Manhole Inspection Summary

Manhole # S13C1_003MH

Location Address: **3107 Georgetown rd (alley behind address)**

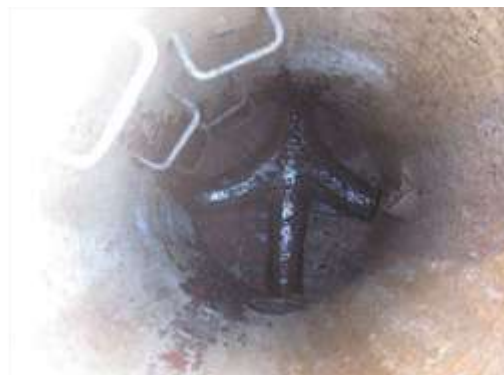
Top View

evidence of corbel infiltration

60cl pipe and drop// parged corbel

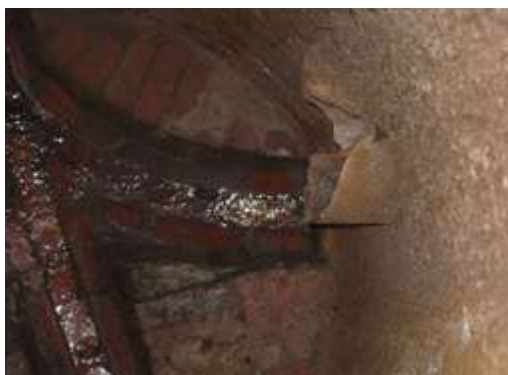
Defect 3

cracked broken pipe at 30cl/ barrel infiltration

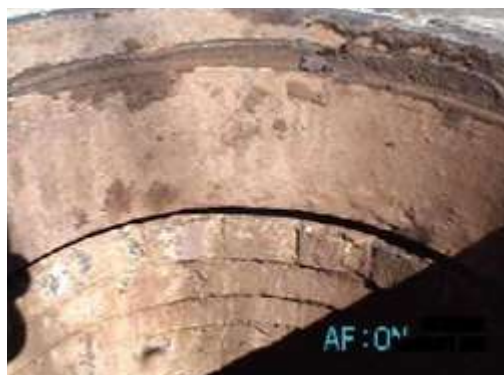
Defect 2

gap between frame and chimney/Chimney infiltration

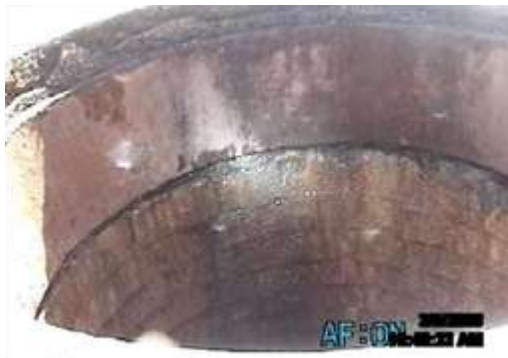
Defect 1

active chimney frame infiltration at three oclock

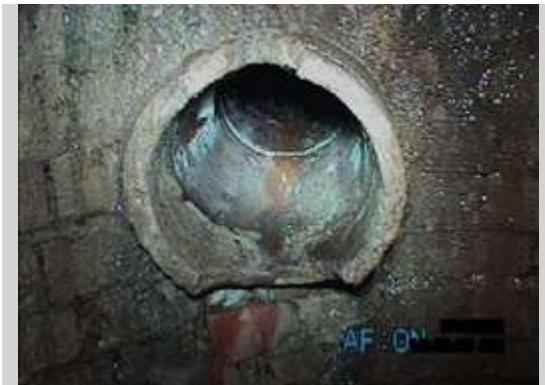
3 O'Clock Inflow

infiltration evidence at in barrel around the drop connection
